# 2022 Data Report for

# Big Bass Lake, Lake County

Site ID: 430029

# Big Bass Lake, Lake County 2022 CLMP Results

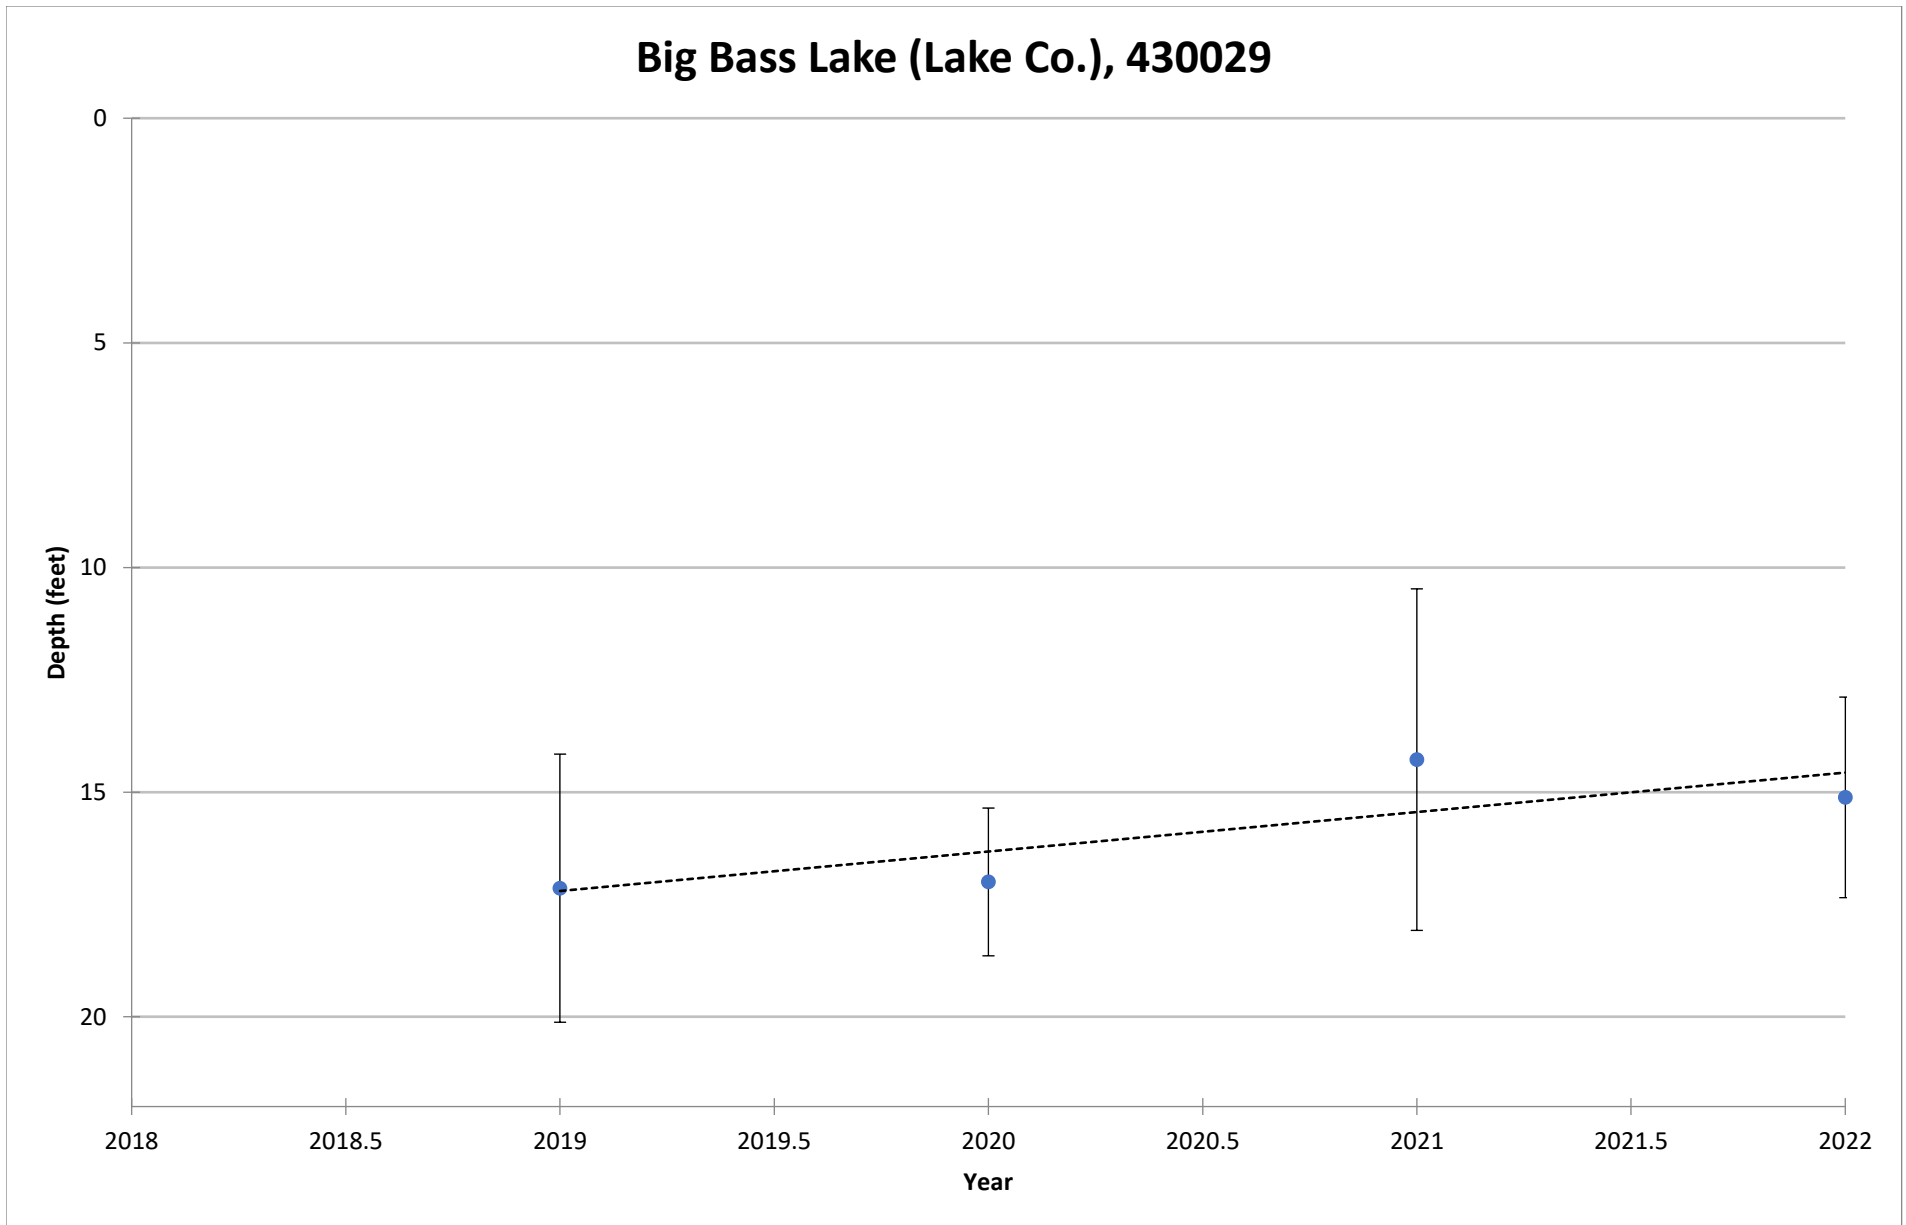
COOPERATIVE LAKES MONITORING PROGRAM  
SUMMER MEAN TRANSPARENCY

**Big Bass Lake (Lake Co.), 430029**

Vertical bars indicate standard deviation

Year	# Readings	Min	Max	Average	Std. Dev	Carlson TSI
2022	17	12.0	19.0	15.1	2.2	38
2019-2021	54	11.0	22.0	15.1	2.8	37
2022 All CLMP Lakes	3178	1.0	63.0	11.6	2.5	43

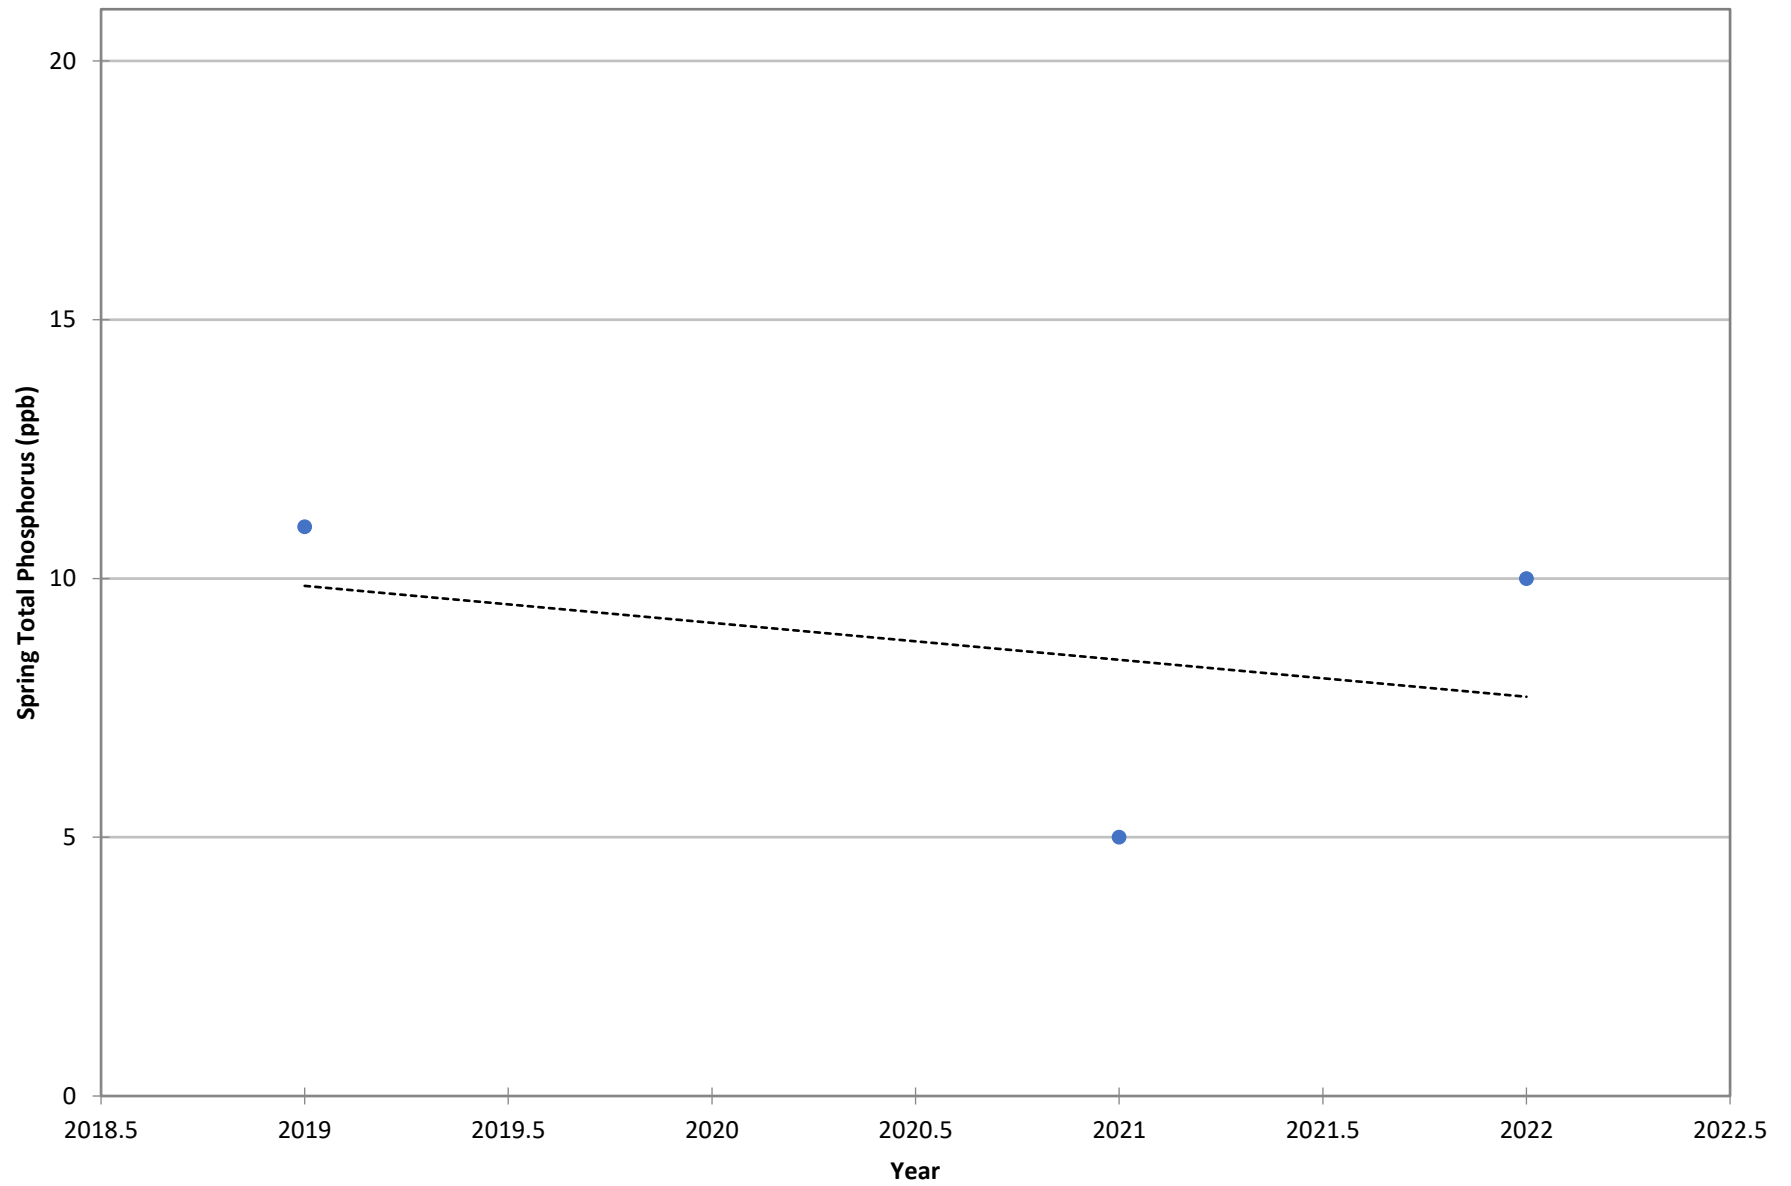
COOPERATIVE LAKES MONITORING PROGRAM  
SPRING TOTAL PHOSPHORUS

**Big Bass Lake (Lake Co.), 430029**

Year	# Samples	Min	Max	Average	Std. Dev
2022	1	10.0	10.0	10.0	NA
2019-2021	2	5.0	11.0	8.0	4.2
2022 All CLMP Lakes	220	<5	220.0	20.7	21.3

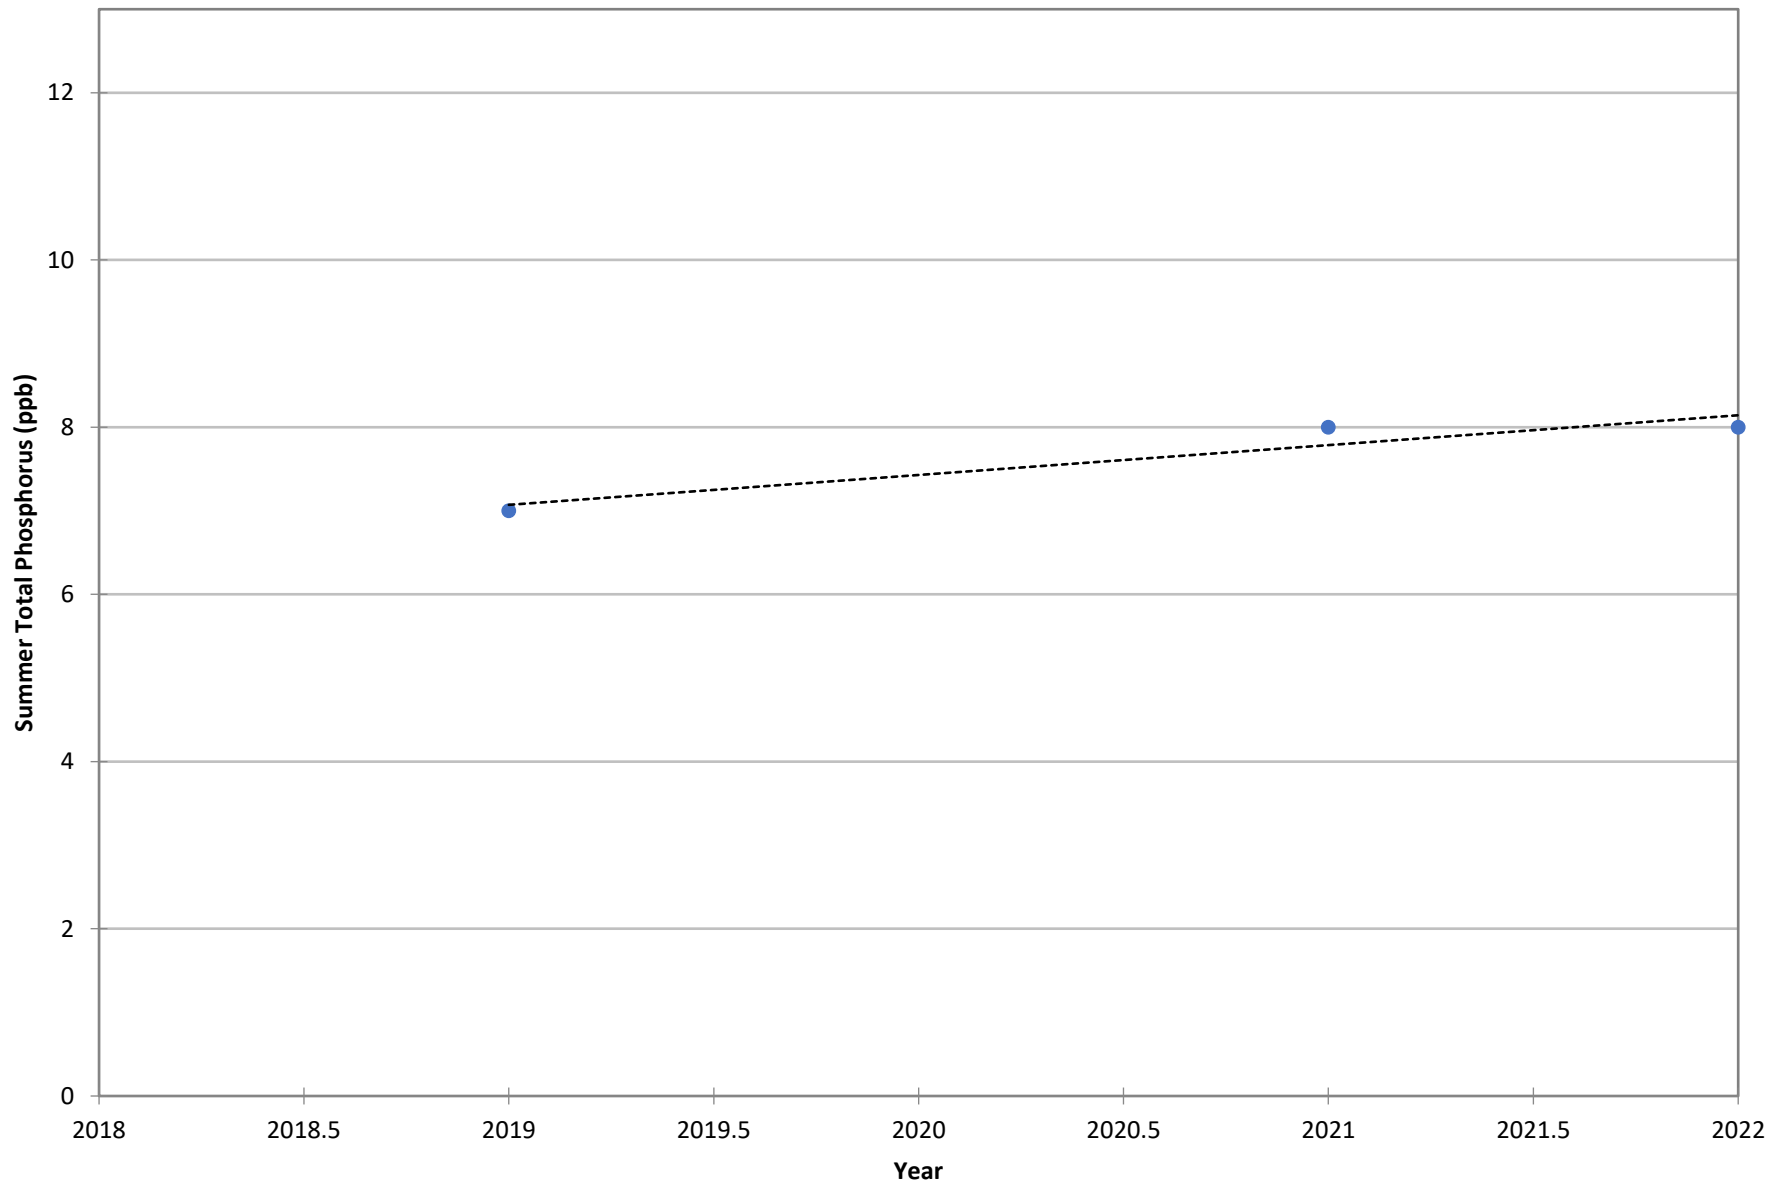
COOPERATIVE LAKES MONITORING PROGRAM  
SUMMER TOTAL PHOSPHORUS

**Big Bass Lake (Lake Co.), 430029**

Year	# Samples	Min	Max	Average	Std. Dev	Carlson TSI
2022	1	8.0	8.0	8.0	NA	34
2019-2021	2	7.0	8.0	7.5	0.7	33
2022 All CLMP Lakes	234	<= 3	150.0	17.4	15.3	45

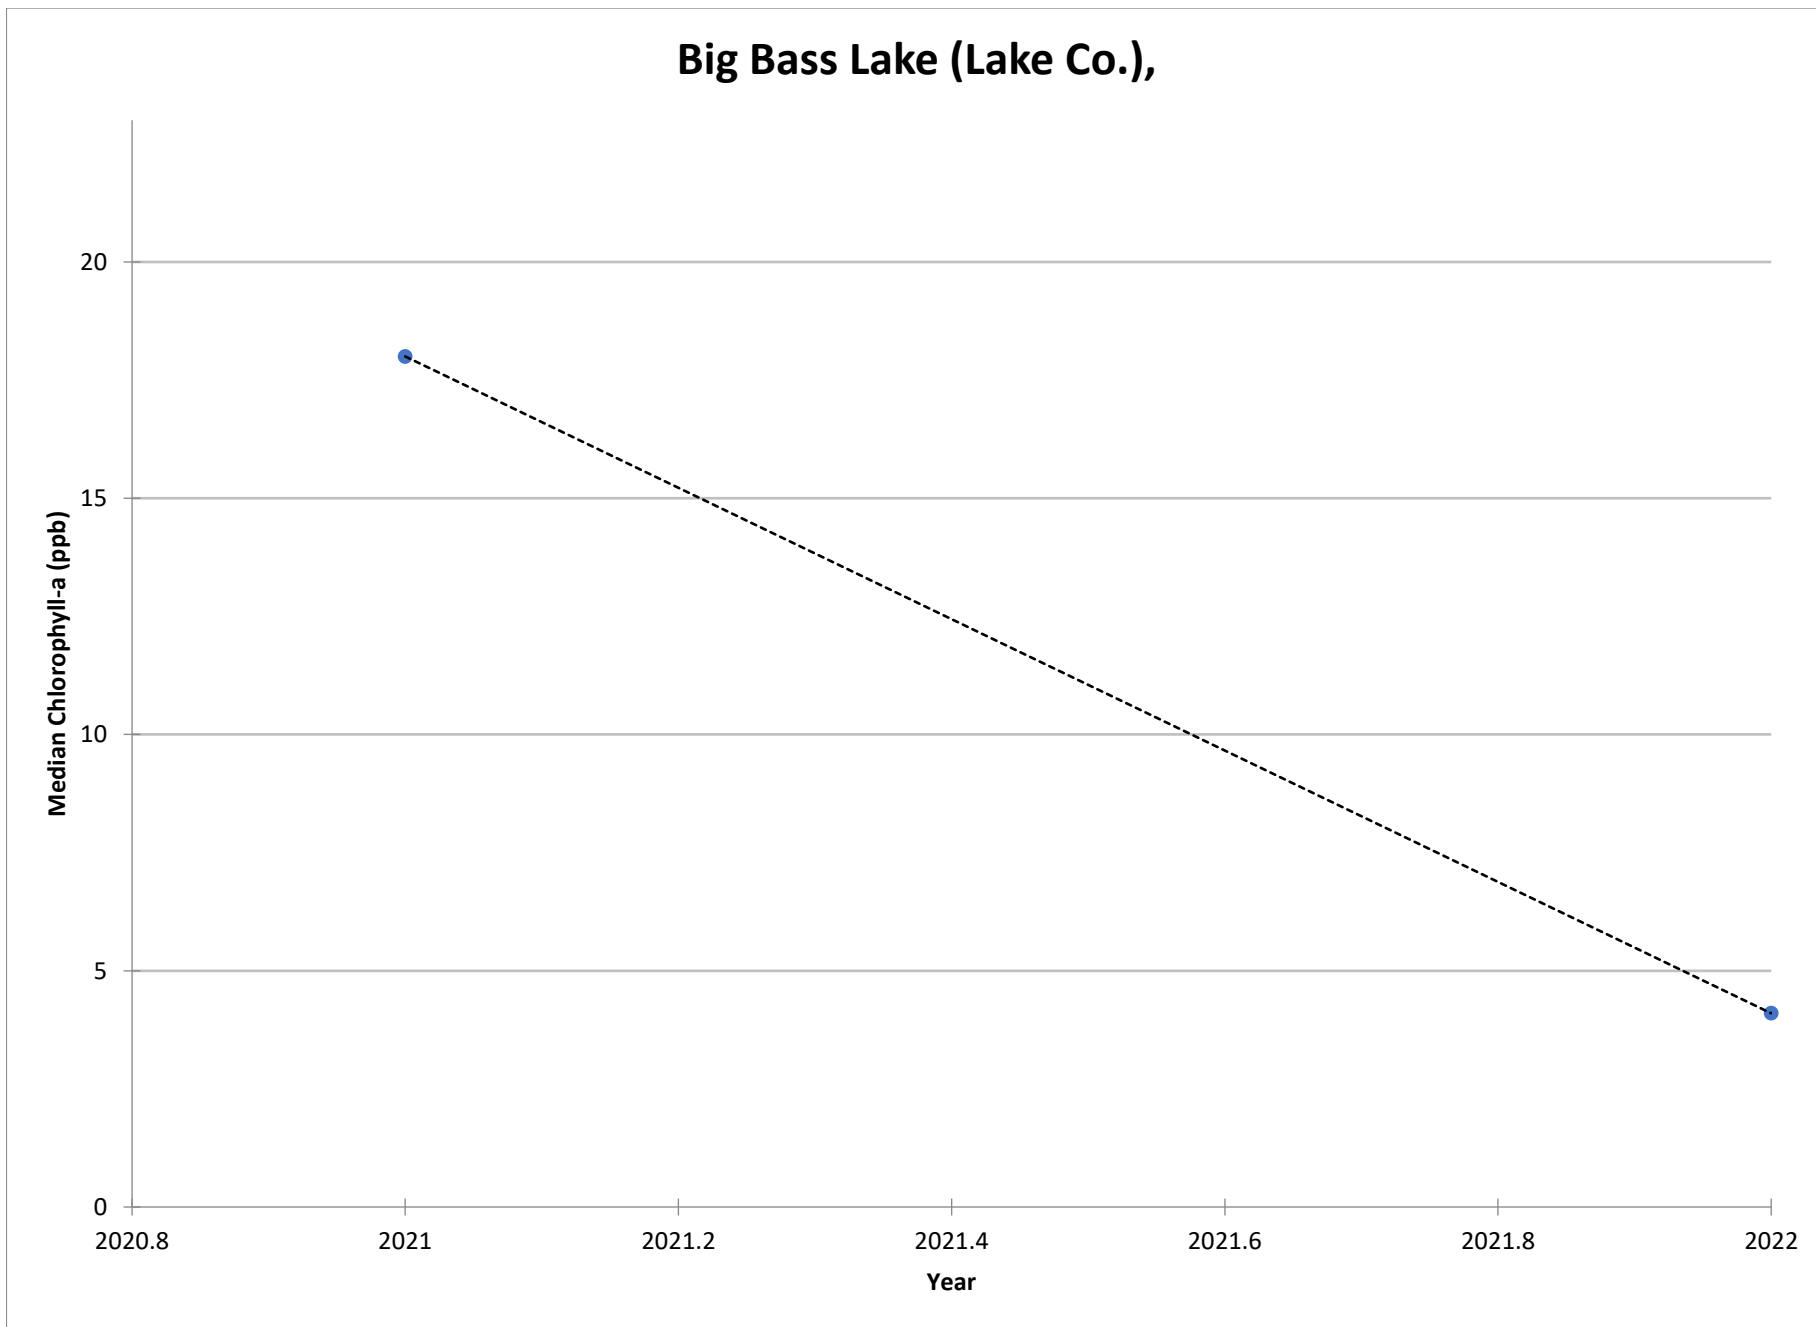
COOPERATIVE LAKES MONITORING PROGRAM  
SUMMER MEDIAN CHLOROPHYLL-A

**Big Bass Lake (Lake Co.),**

Vertical bars indicate standard deviation

Year	# Samples	Min	Max	Median	Std. Dev	Carlson TSI
2022	5	<1.0	10.0	4.1	3.6	44
2021	5	2.0	100.0	18.0	40.0	59
2022 All CLMP Lakes	687	< 1.0	43.0	3.7	5.3	43

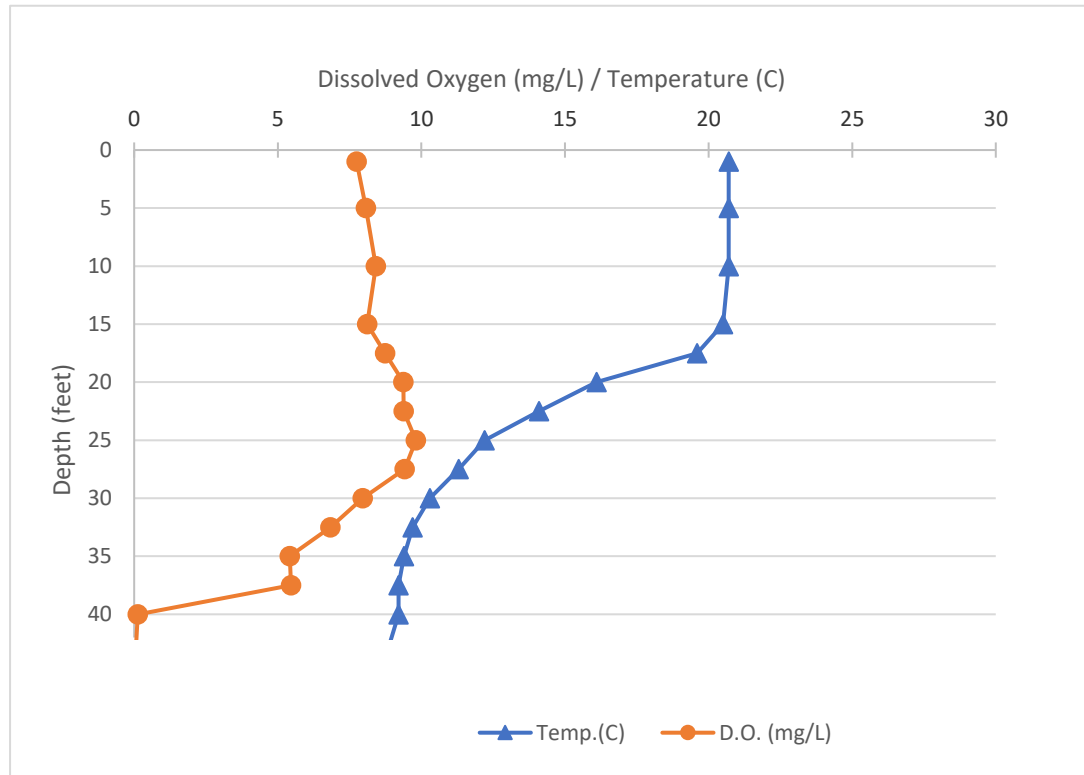
Name: Big Bass Lake  
 County: Lake  
 Site ID: 430029  
 Date: 6/7/2022

Depth (ft)	Temp.(C)	D.O. (mg/L)
1	20.7	7.75
5	20.7	8.07
10	20.7	8.42
15	20.5	8.11
17.5	19.6	8.74
20	16.1	9.37
22.5	14.1	9.38
25	12.2	9.81
27.5	11.3	9.42
30	10.3	7.96
32.5	9.7	6.83
35	9.4	5.42
37.5	9.2	5.46
40	9.2	0.12
42.5	8.9	0.07

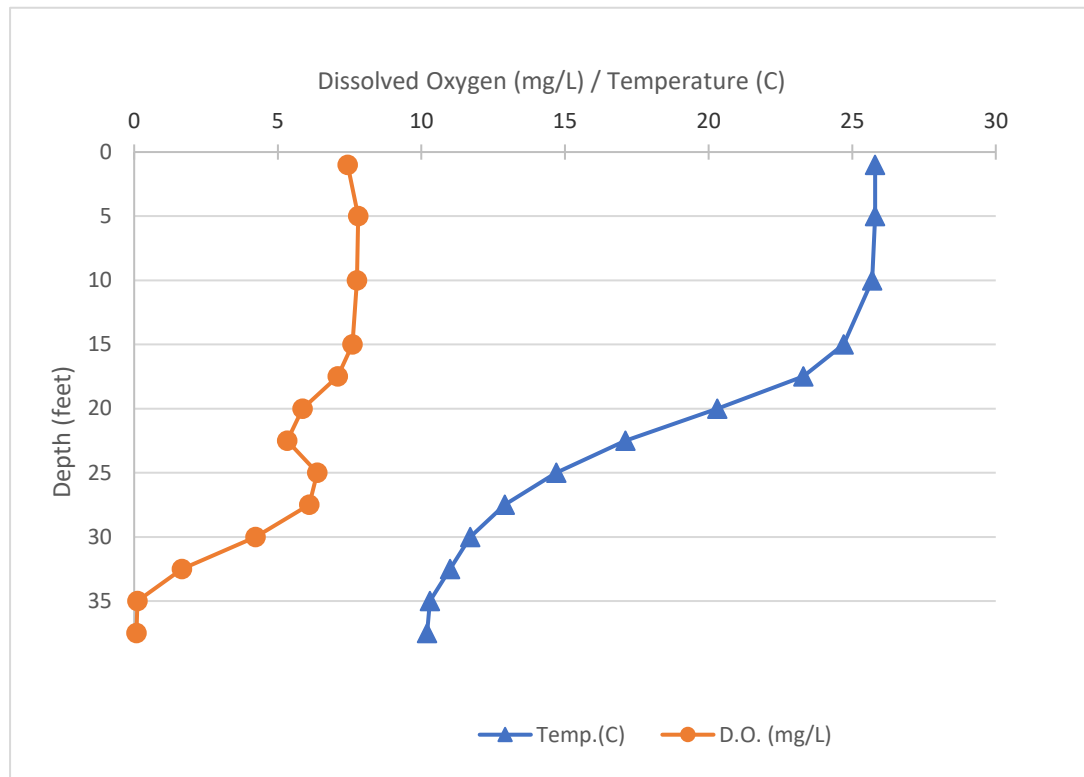
Name: Big Bass Lake  
County: Lake  
Site ID: 430029  
Date: 7/6/2022

Depth (ft)	Temp.(C)	D.O. (mg/L)
1	25.8	7.43
5	25.8	7.8
10	25.7	7.76
15	24.7	7.6
17.5	23.3	7.09
20	20.3	5.86
22.5	17.1	5.33
25	14.7	6.37
27.5	12.9	6.1
30	11.7	4.23
32.5	11	1.66
35	10.3	0.11
37.5	10.2	0.08

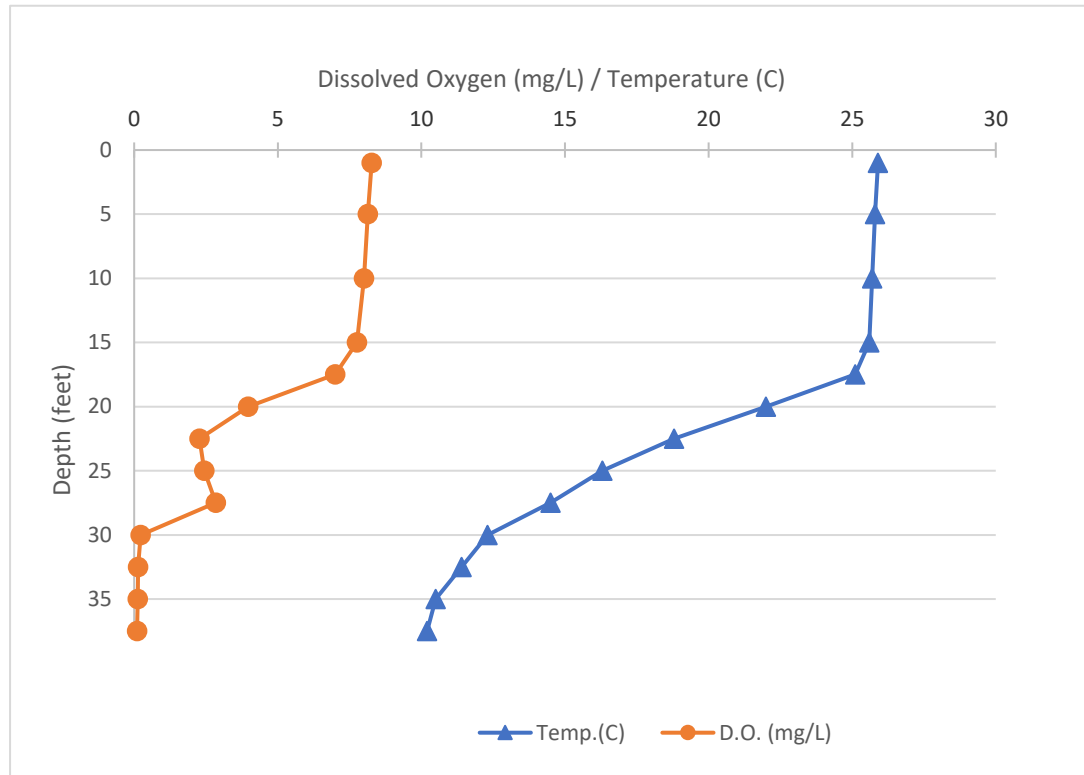
Name: Big Bass Lake  
 County: Lake  
 Site ID: 430029  
 Date: 7/26/2022

Depth (ft)	Temp.(C)	D.O. (mg/L)
1	25.9	8.27
5	25.8	8.14
10	25.7	8
15	25.6	7.76
17.5	25.1	7
20	22	3.97
22.5	18.8	2.28
25	16.3	2.44
27.5	14.5	2.84
30	12.3	0.23
32.5	11.4	0.14
35	10.5	0.12
37.5	10.2	0.1

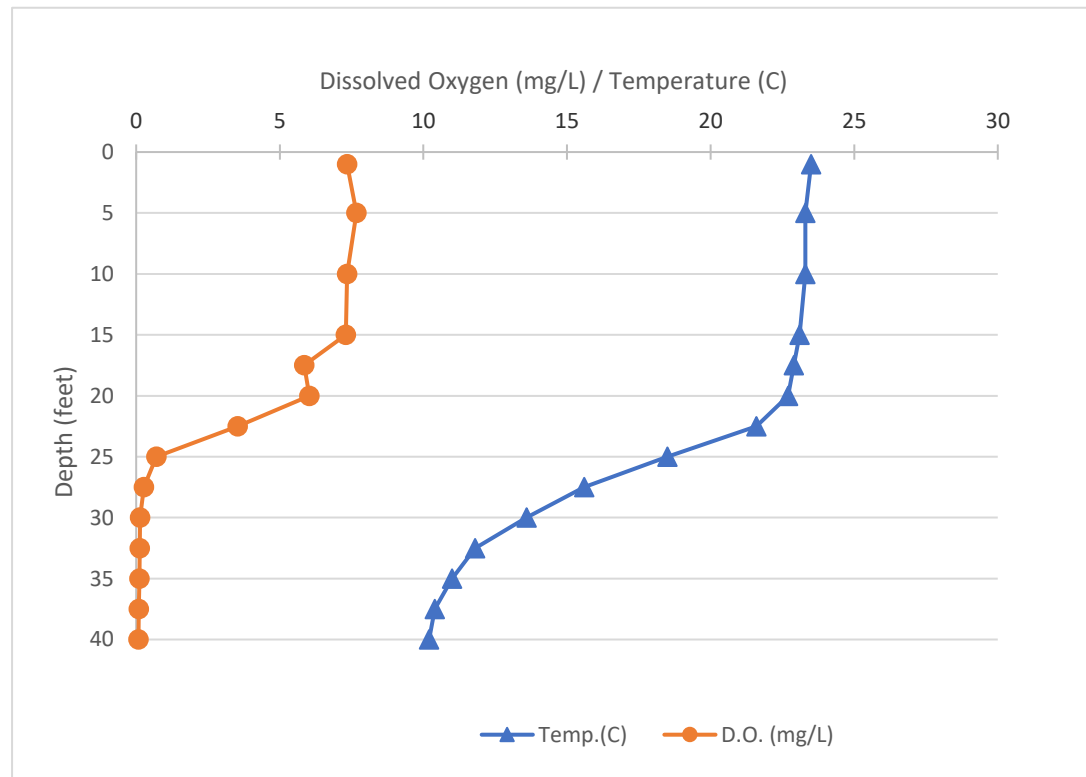
Name: Big Bass Lake  
 County: Lake  
 Site ID: 430029  
 Date: 8/15/2022

Depth (ft)	Temp.(C)	D.O. (mg/L)
1	23.5	7.34
5	23.3	7.67
10	23.3	7.34
15	23.1	7.3
17.5	22.9	5.85
20	22.7	6.03
22.5	21.6	3.53
25	18.5	0.7
27.5	15.6	0.27
30	13.6	0.14
32.5	11.8	0.12
35	11	0.11
37.5	10.4	0.09
40	10.2	0.08

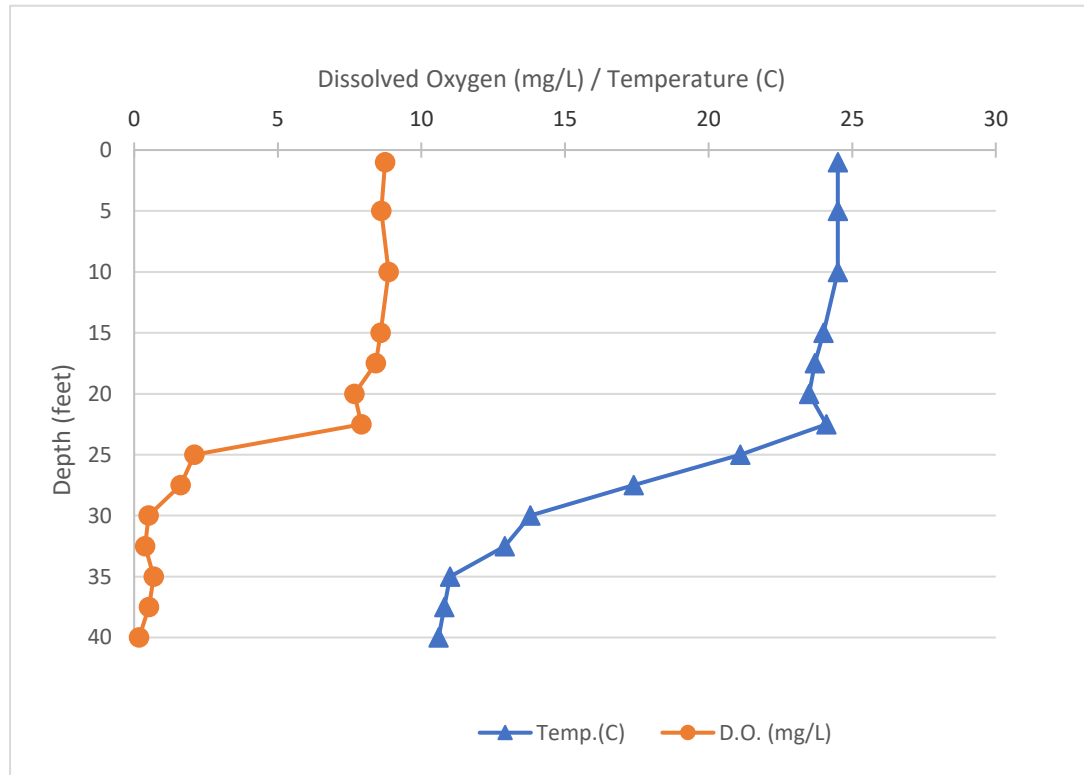
Name: Big Bass Lake  
 County: Lake  
 Site ID: 430029  
 Date: 9/2/2022

Depth (ft)	Temp.(C)	D.O. (mg/L)
1	24.5	8.74
5	24.5	8.6
10	24.5	8.86
15	24	8.58
17.5	23.7	8.41
20	23.5	7.67
22.5	24.1	7.91
25	21.1	2.1
27.5	17.4	1.62
30	13.8	0.5
32.5	12.9	0.38
35	11	0.68
37.5	10.8	0.51
40	10.6	0.17
