# **2022 Data Report for Little Bass Lake, Lake County**

Site ID: 430640

# Little Bass Lake, Lake County 2022 CLMP Results

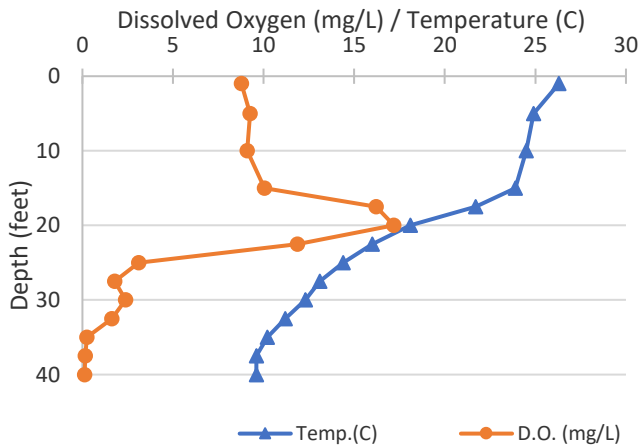
8/24/2022

## Dissolved Oxygen and Temperature Profile

This lake does not stratify like a typical Michigan lake; it does develop anoxic waters on the bottom but the oxygen in the thermocline (about at a depth of 20) gets very high, possibly due to bands of algae conducting photosynthesis in this section of the lake.

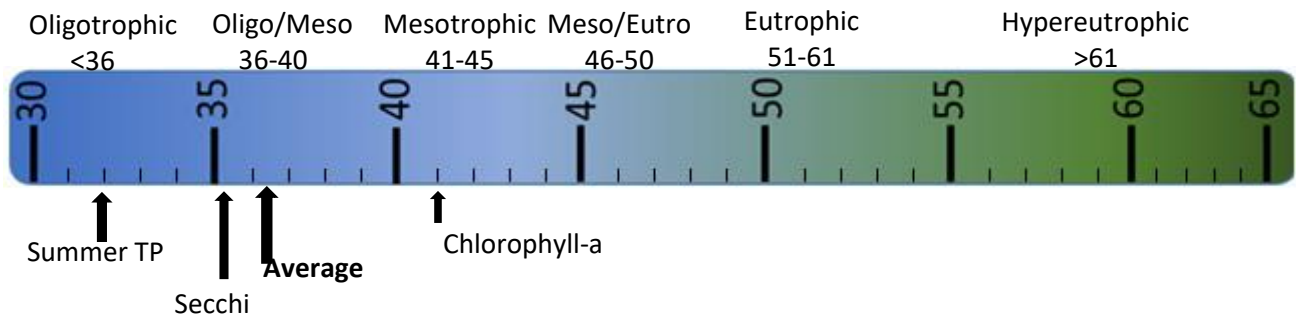
In 1977, limnologist Dr. Robert Carlson developed a numerical scale (0-100) where the numbers indicate the level of nutrient enrichment. Using the proper equations, we can convert results from Summer Total Phosphorus, Secchi Depth, and Chlorophyll-a to this Trophic Status Index (TSI). The TSI numbers are furthermore grouped into general categories (oligotrophic, mesotrophic, eutrophic, and hypereutrophic), to quickly give us a way to understand the general nutrient level of any lake.

TSI for Little Bass Lake in 2022	
Average	36
Secchi Disk	35
Summer TP	32
Chlorophyll-a	41

With an average TSI score of 36 based on 2022 Secchi transparency, chlorophyll-a, and summer total phosphorus data, this lake is rated between the oligotrophic and mesotrophic lake classification. The lake leans slightly more oligotrophic than mesotrophic.

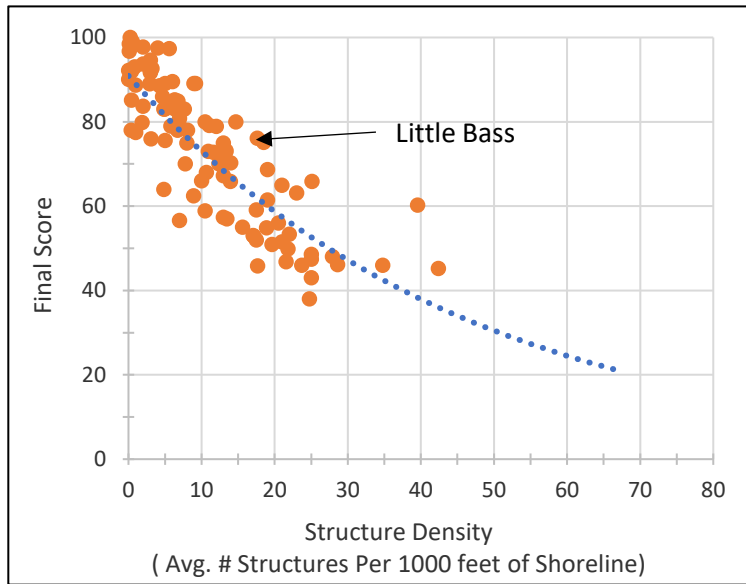
Little Bass Lake	
Number of Sections:	8
Number of Structures:	141
Structure Density:	17.6
Final Score:	76.1

All 97 Participating Lakes from 2015-2022:	
Avg. Number of Sections:	16
Avg. Number of Structures:	228
Avg. Structure Density:	12
Avg. Final Score:	73

Note about graph to the left: The dotted line sets your average expectation of the score of your lake. If your lake is lower than the dotted line, then your shoreline health is lower than average compared to lakes with similar amount of shoreline development. And vice-versa in regards to a lake above the dotted line.

Overall, the lakeshore habitat of Little Bass Lake scored above average when compared to other lakes in the program with similar amount of development. All of the 1000 foot sections scored either Fair or Good (3 fair and 5 good).

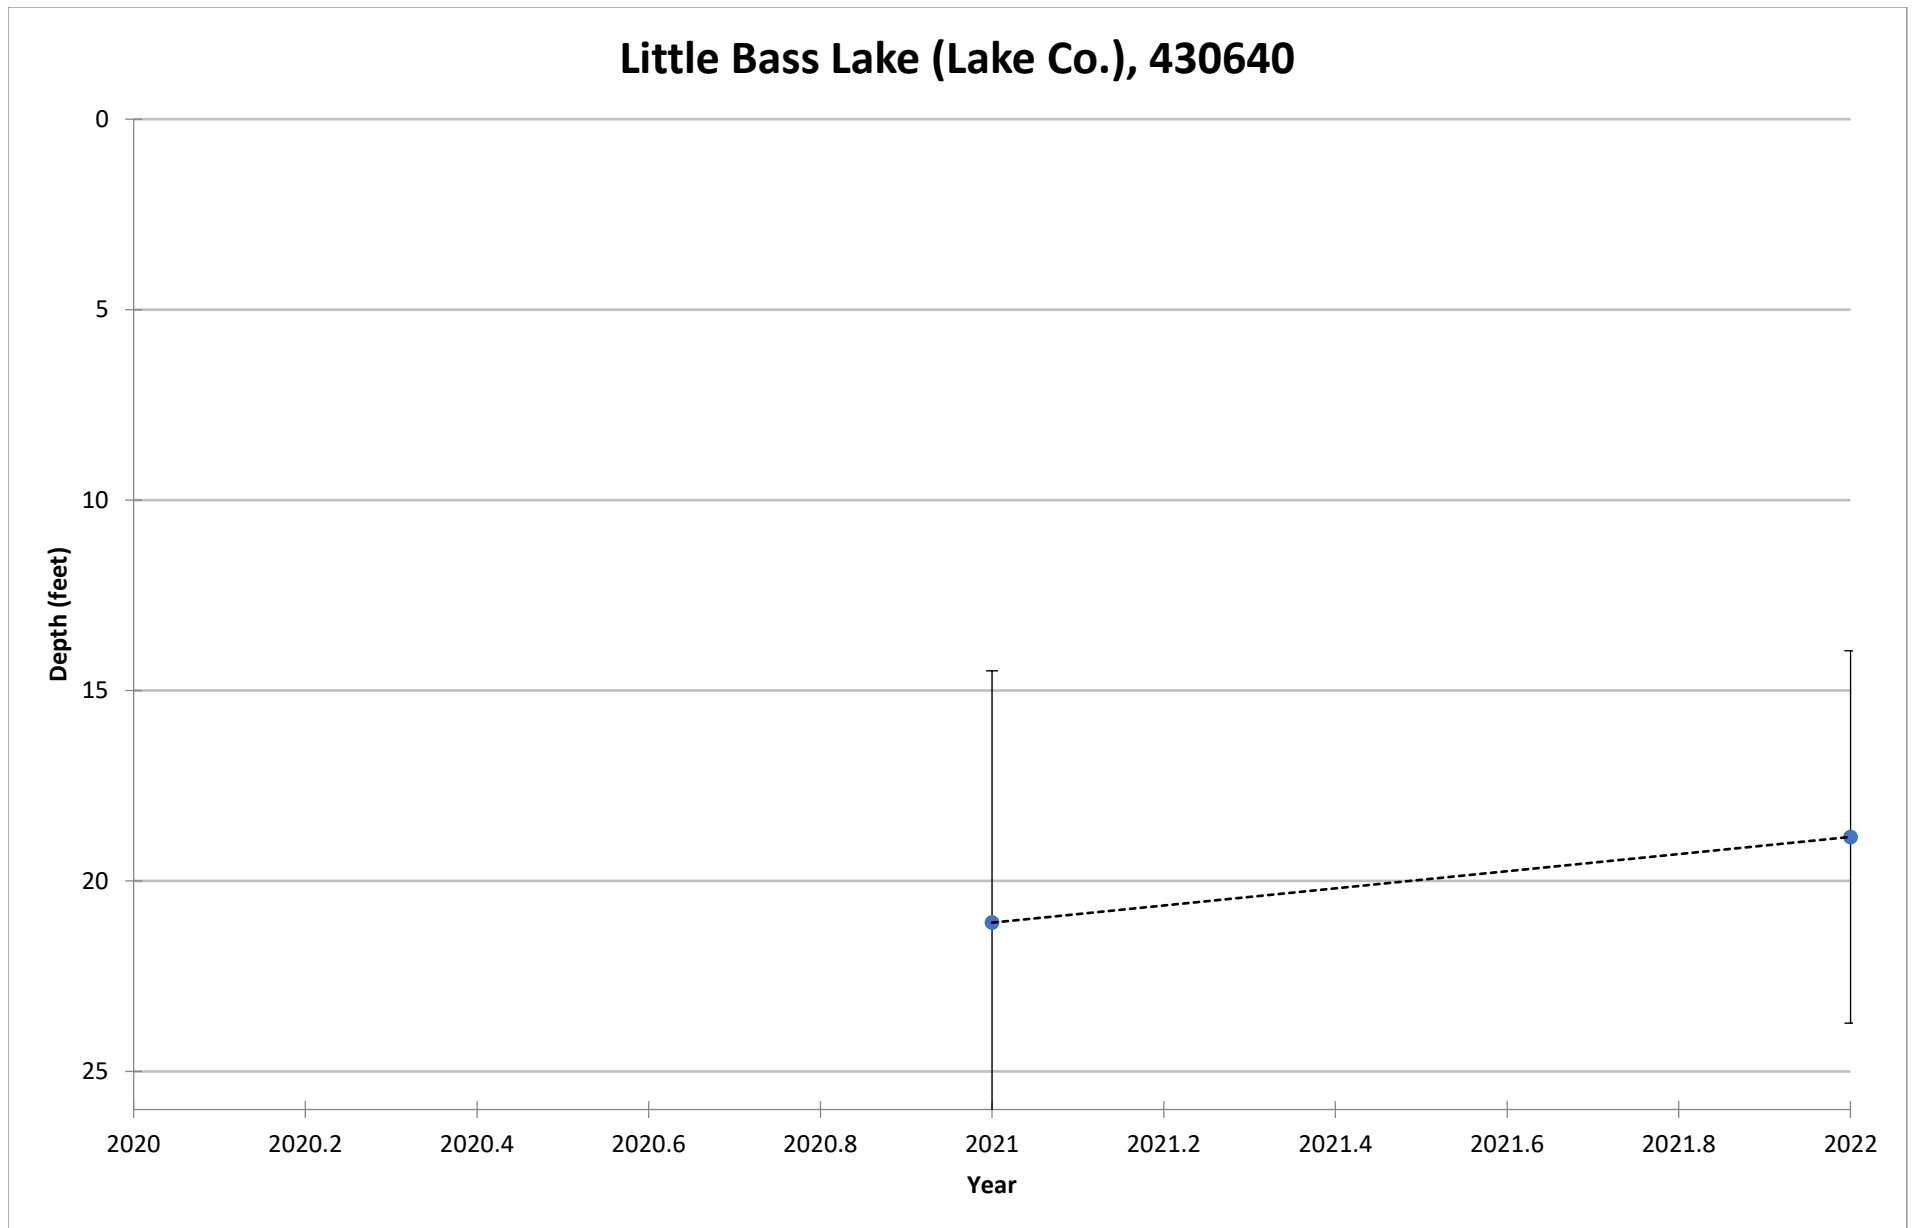
COOPERATIVE LAKES MONITORING PROGRAM  
SUMMER MEAN TRANSPARENCY

**Little Bass Lake (Lake Co.), 430640**

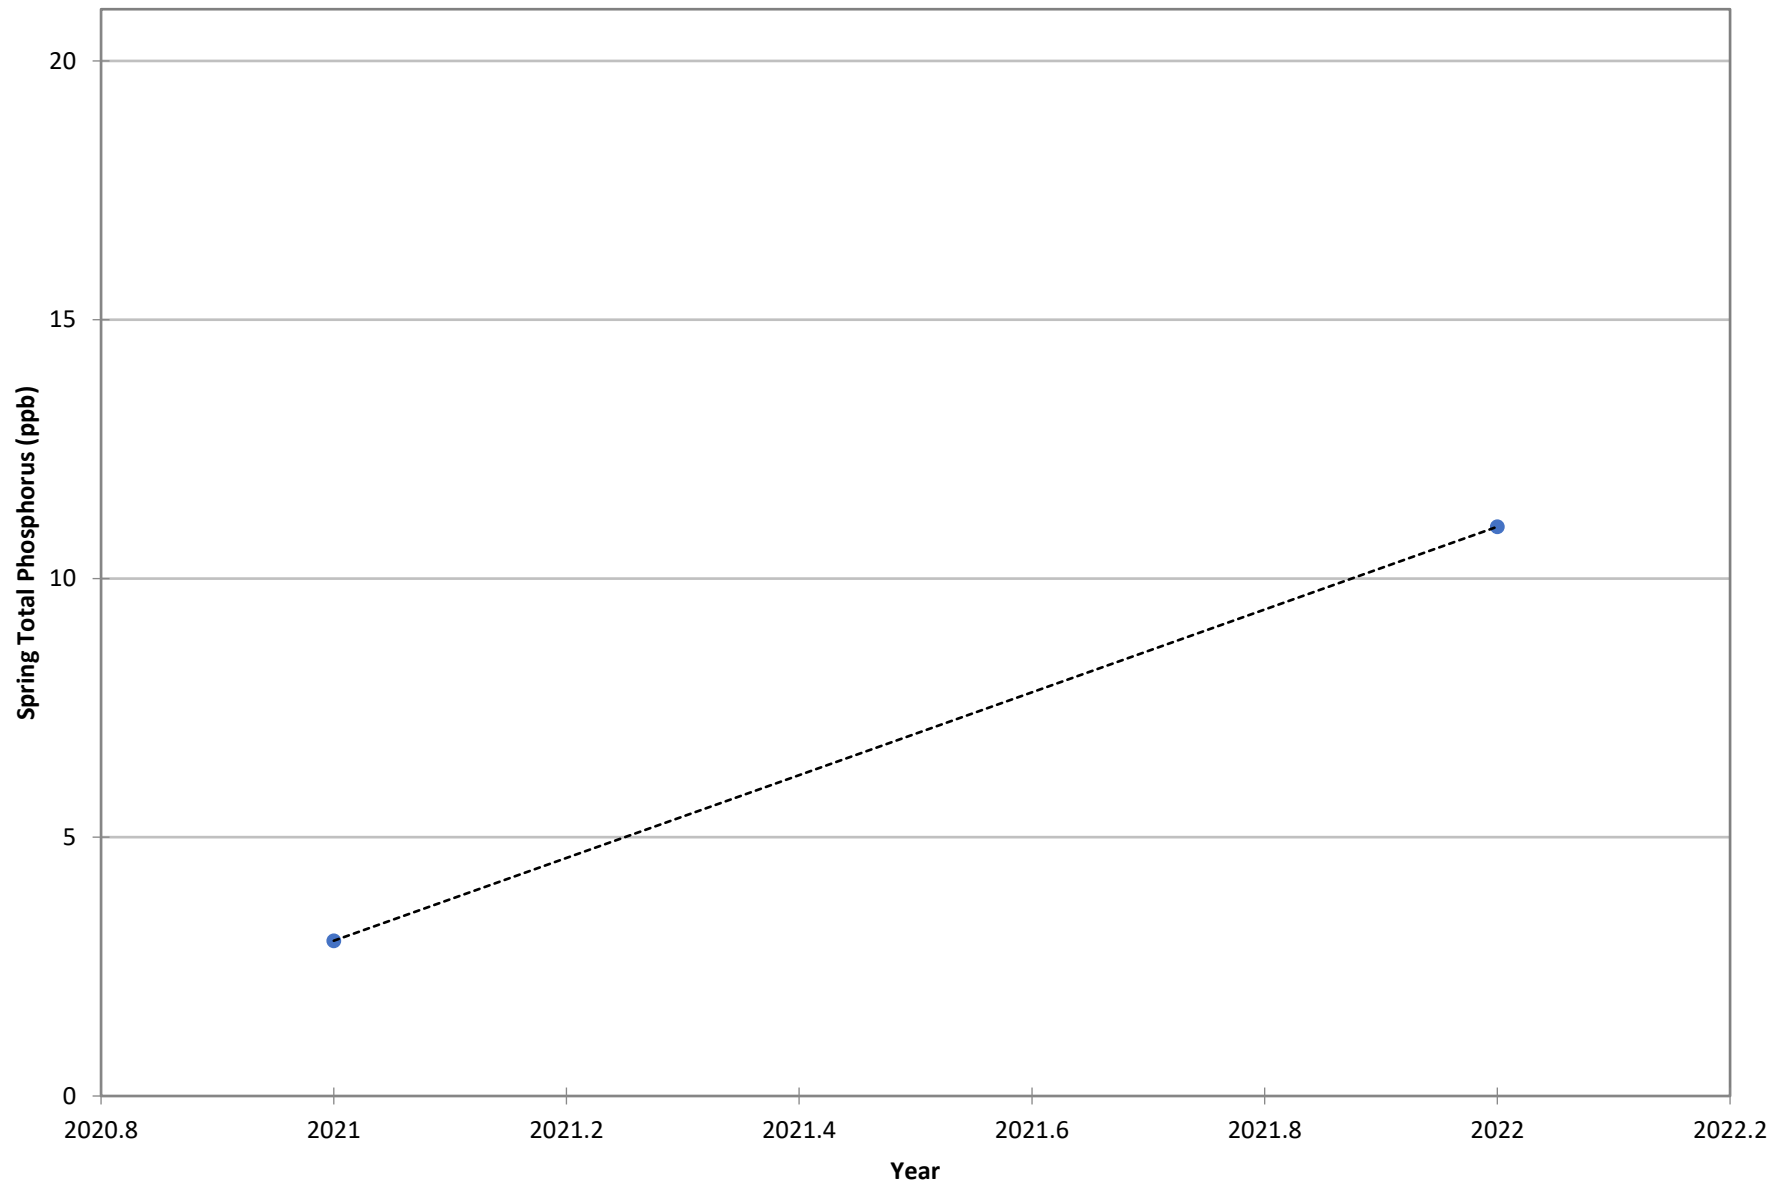
COOPERATIVE LAKES MONITORING PROGRAM  
SPRING TOTAL PHOSPHORUS

**Little Bass Lake (Lake Co.), 430640**

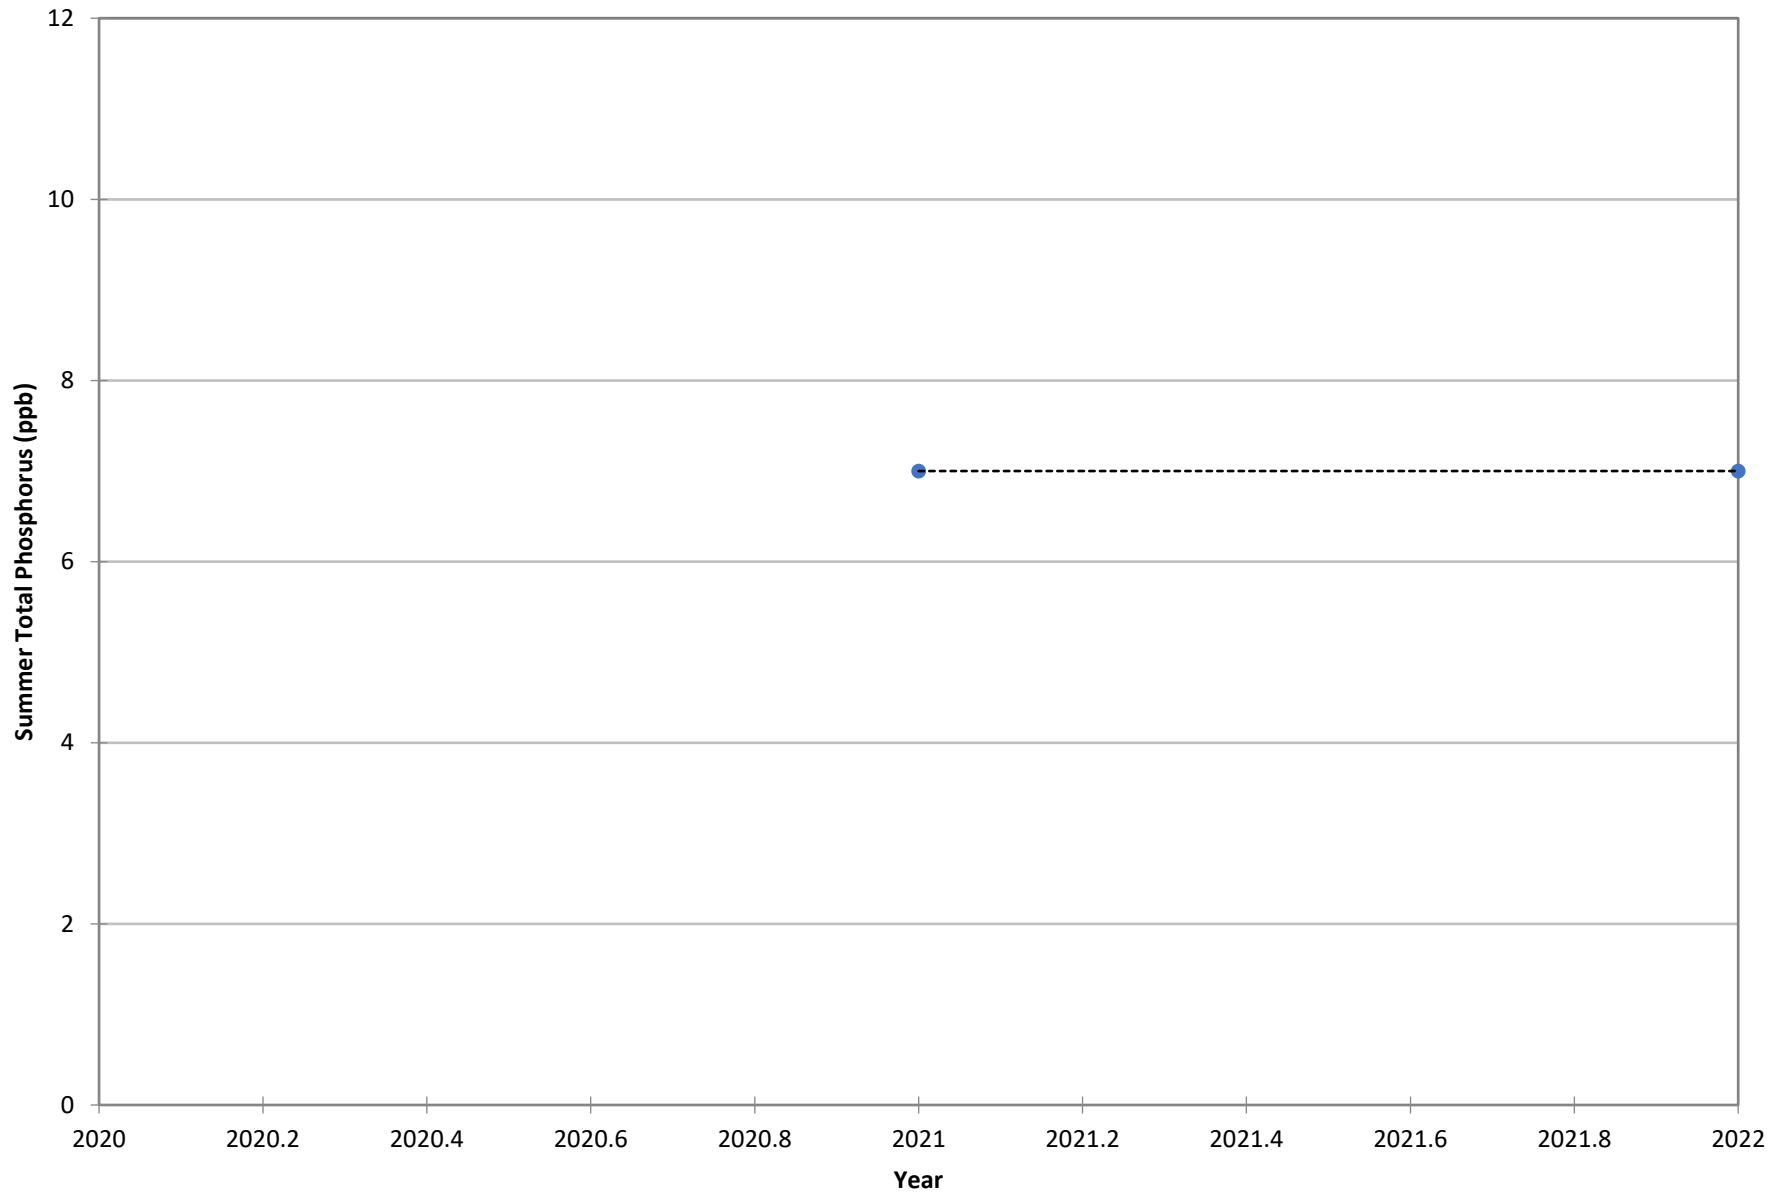
COOPERATIVE LAKES MONITORING PROGRAM  
SUMMER TOTAL PHOSPHORUS

**Little Bass Lake (Lake Co.), 430640**

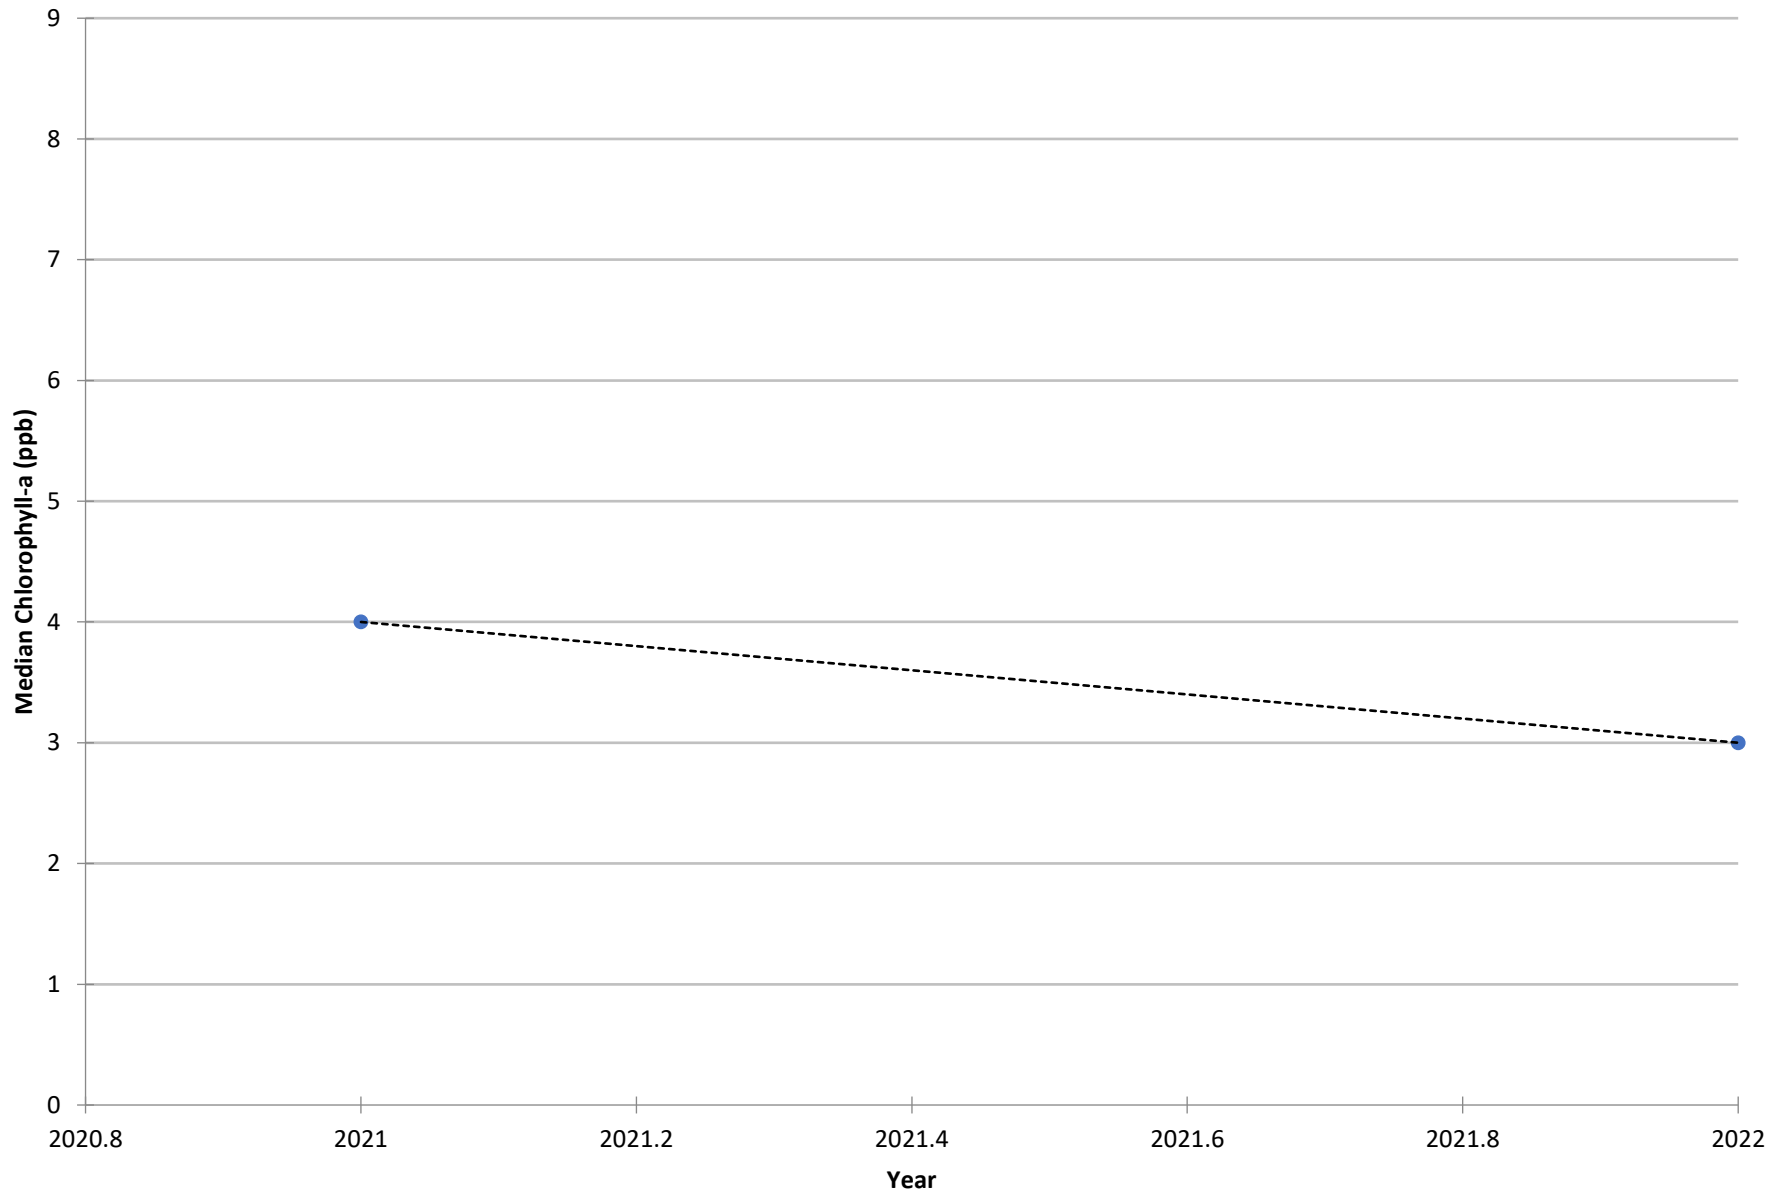
COOPERATIVE LAKES MONITORING PROGRAM  
SUMMER MEDIAN CHLOROPHYLL-A

### Little Bass Lake (Lake Co.)

Vertical bars indicate standard deviation

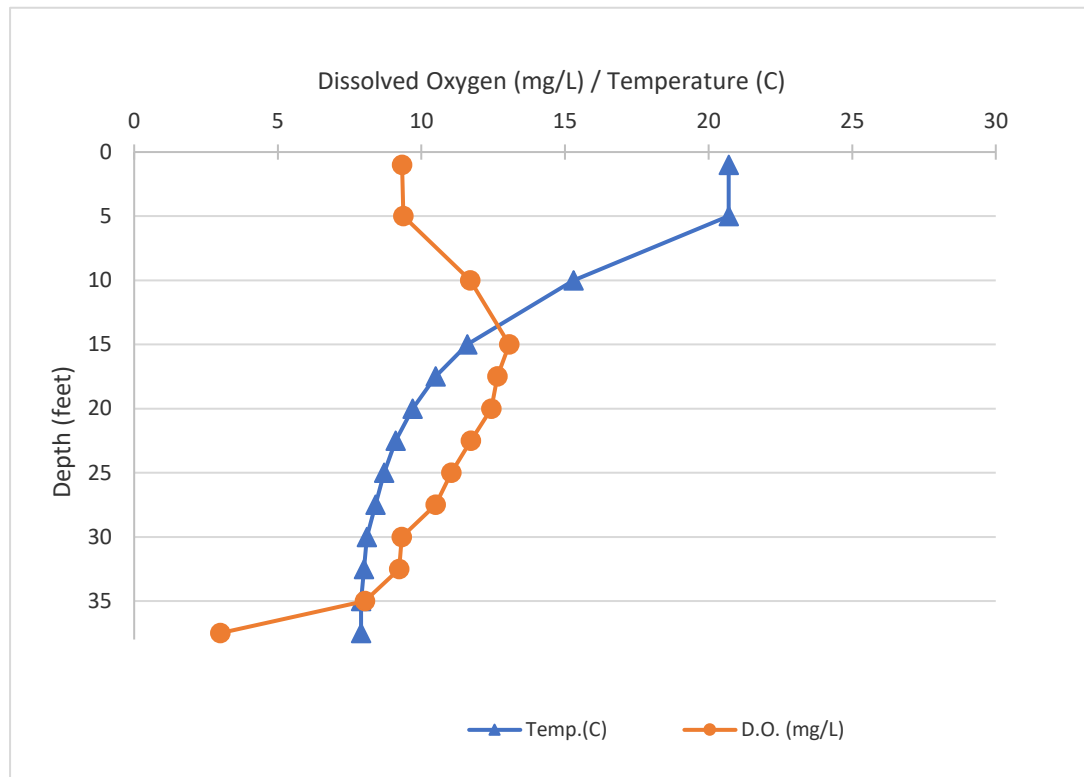
5/16/2022

### Dissolved Oxygen and Temperature Profile

Depth (ft)	Temp.(C)	D.O. (mg/L)
1	20.7	9.33
5	20.7	9.37
10	15.3	11.7
15	11.6	13.06
17.5	10.5	12.65
20	9.7	12.44
22.5	9.1	11.72
25	8.7	11.04
27.5	8.4	10.5
30	8.1	9.32
32.5	8	9.23
35	7.9	8.04
37.5	7.9	3

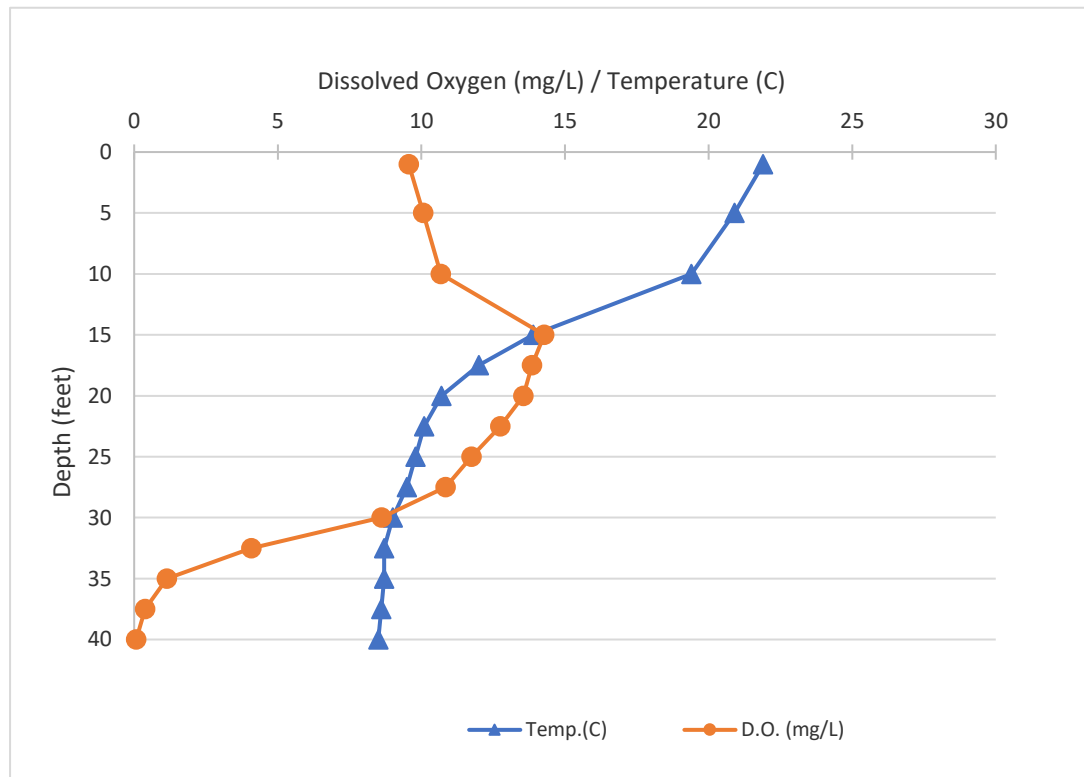
5/31/2022

### Dissolved Oxygen and Temperature Profile

Depth (ft)	Temp.(C)	D.O. (mg/L)
1	21.9	9.56
5	20.9	10.06
10	19.4	10.68
15	13.9	14.28
17.5	12	13.85
20	10.7	13.55
22.5	10.1	12.75
25	9.8	11.75
27.5	9.5	10.84
30	9	8.62
32.5	8.7	4.08
35	8.7	1.14
37.5	8.6	0.38
40	8.5	0.07

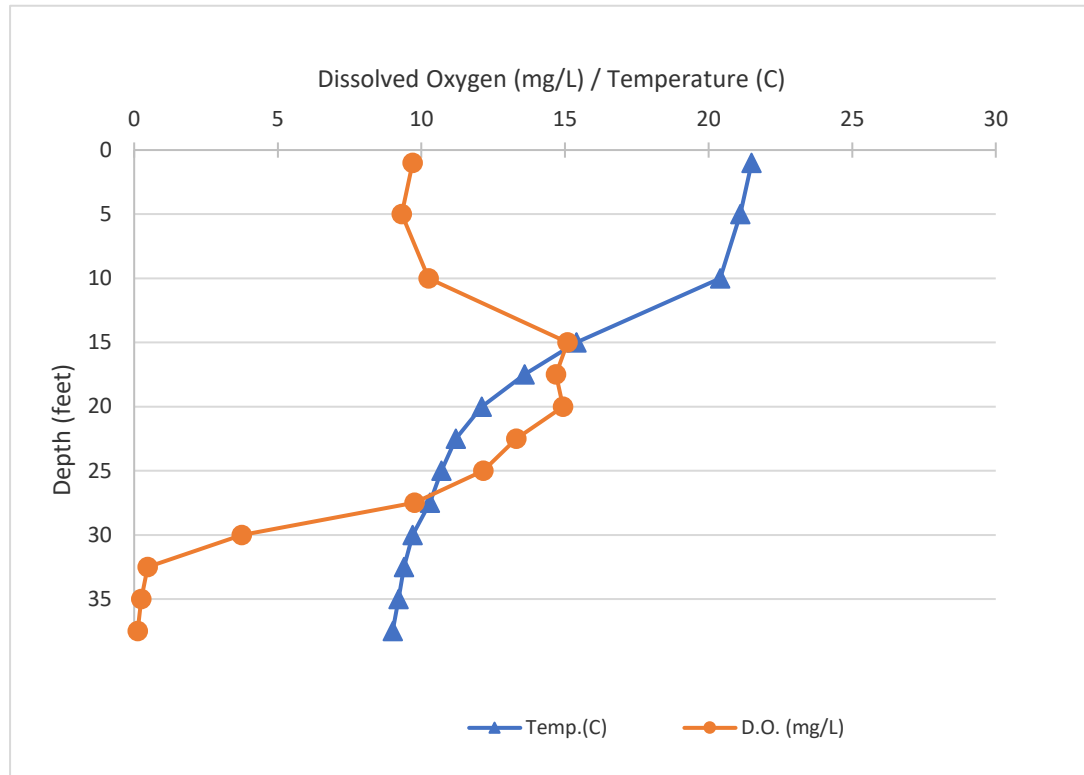
6/14/2022

### Dissolved Oxygen and Temperature Profile

Depth (ft)	Temp.(C)	D.O. (mg/L)
1	21.5	9.7
5	21.1	9.32
10	20.4	10.25
15	15.4	15.09
17.5	13.6	14.69
20	12.1	14.93
22.5	11.2	13.31
25	10.7	12.16
27.5	10.3	9.76
30	9.7	3.75
32.5	9.4	0.47
35	9.2	0.25
37.5	9	0.12

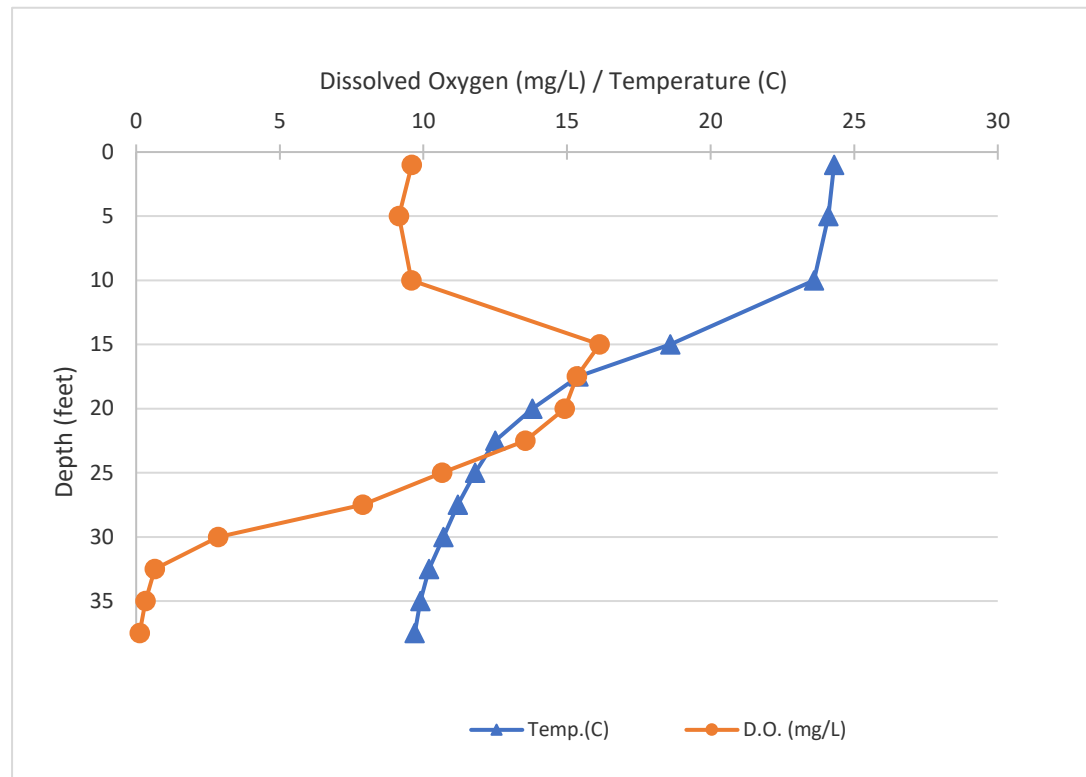
6/30/2022

### Dissolved Oxygen and Temperature Profile

Depth (ft)	Temp.(C)	D.O. (mg/L)
1	24.3	9.6
5	24.1	9.15
10	23.6	9.58
15	18.6	16.14
17.5	15.4	15.35
20	13.8	14.92
22.5	12.5	13.55
25	11.8	10.65
27.5	11.2	7.89
30	10.7	2.85
32.5	10.2	0.65
35	9.9	0.33
37.5	9.7	0.12

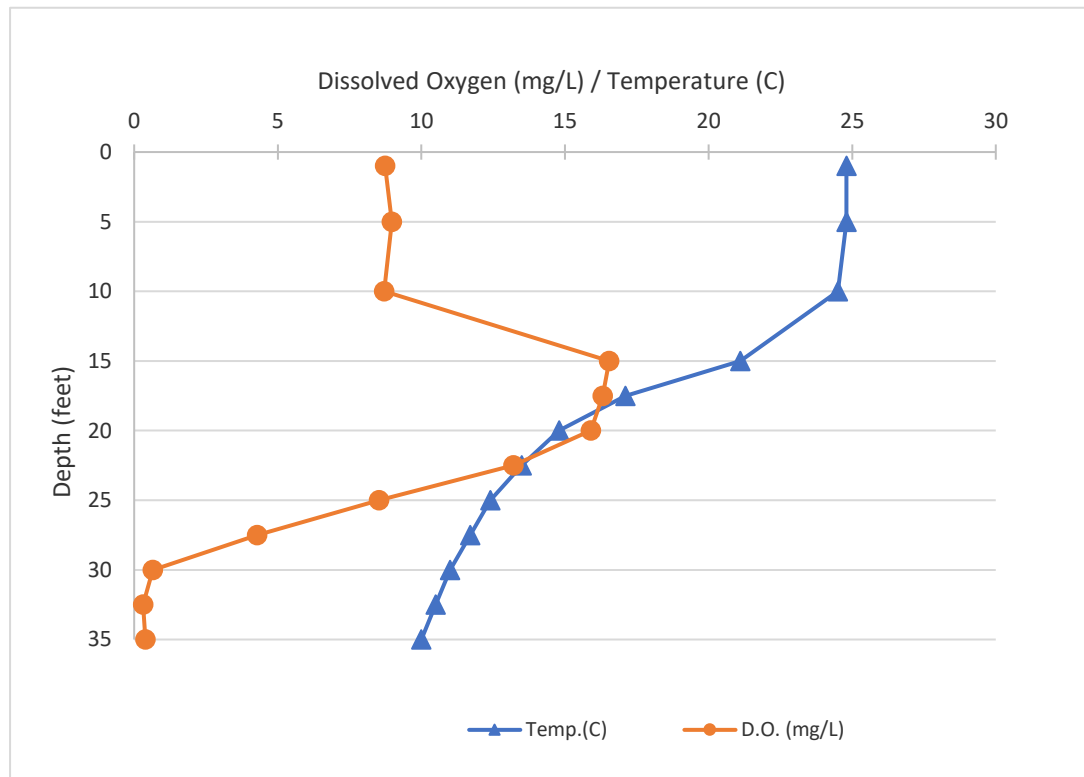
7/13/2022

### Dissolved Oxygen and Temperature Profile

Depth (ft)	Temp.(C)	D.O. (mg/L)
1	24.8	8.74
5	24.8	8.97
10	24.5	8.7
15	21.1	16.54
17.5	17.1	16.31
20	14.8	15.9
22.5	13.5	13.21
25	12.4	8.53
27.5	11.7	4.28
30	11	0.65
32.5	10.5	0.31
35	10	0.39

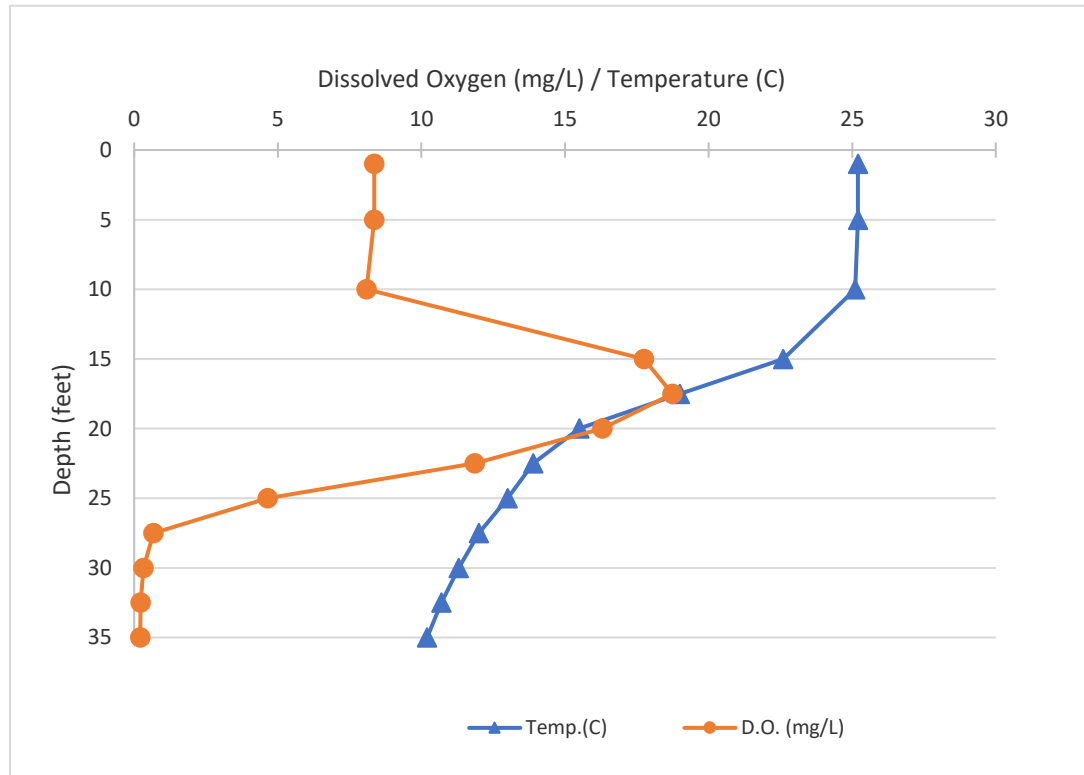
7/29/2022

### Dissolved Oxygen and Temperature Profile

Depth (ft)	Temp.(C)	D.O. (mg/L)
1	25.2	8.36
5	25.2	8.36
10	25.1	8.09
15	22.6	17.75
17.5	19	18.74
20	15.5	16.3
22.5	13.9	11.86
25	13	4.65
27.5	12	0.67
30	11.3	0.32
32.5	10.7	0.23
35	10.2	0.21

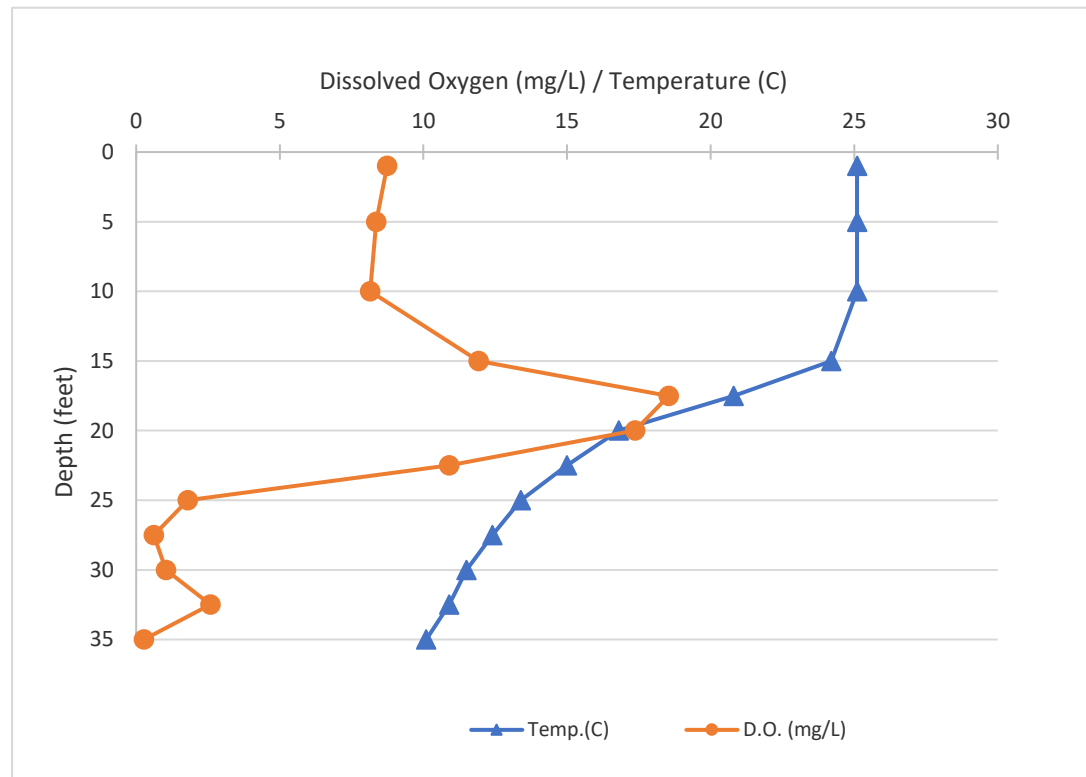
8/11/2022

### Dissolved Oxygen and Temperature Profile

Depth (ft)	Temp.(C)	D.O. (mg/L)
1	25.1	8.74
5	25.1	8.36
10	25.1	8.15
15	24.2	11.92
17.5	20.8	18.54
20	16.8	17.37
22.5	15	10.9
25	13.4	1.8
27.5	12.4	0.62
30	11.5	1.04
32.5	10.9	2.59
35	10.1	0.27

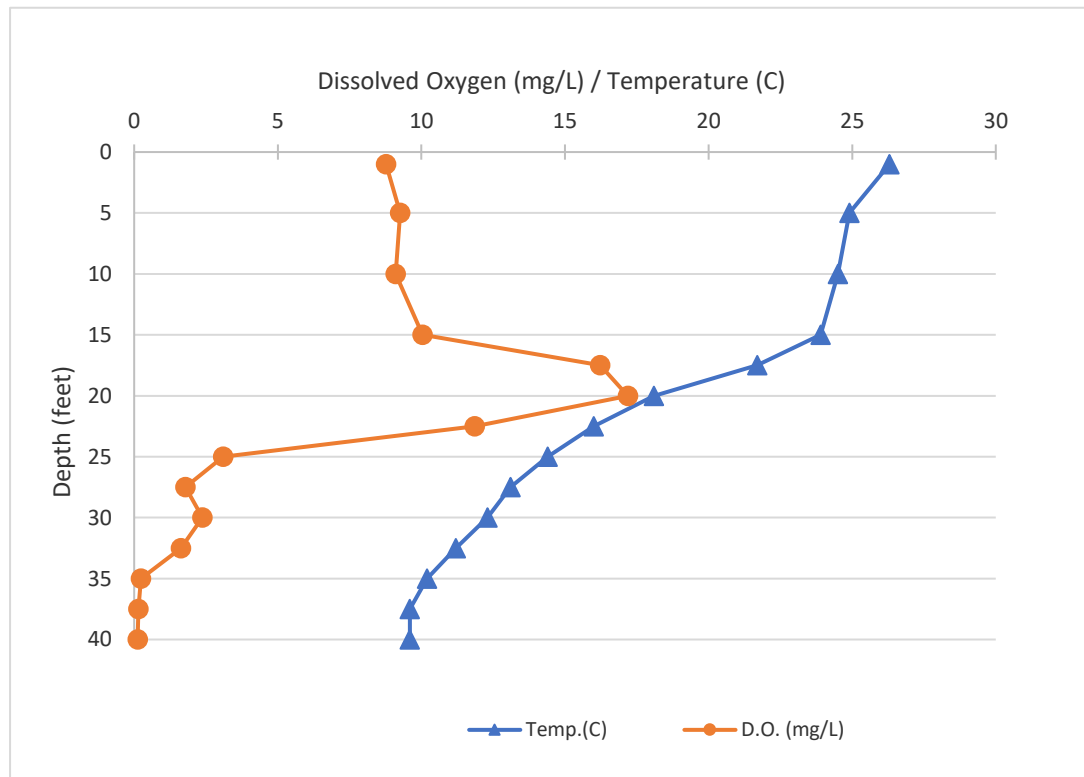
8/24/2022

### Dissolved Oxygen and Temperature Profile

Depth (ft)	Temp.(C)	D.O. (mg/L)
1	26.3	8.77
5	24.9	9.26
10	24.5	9.1
15	23.9	10.04
17.5	21.7	16.22
20	18.1	17.19
22.5	16	11.86
25	14.4	3.1
27.5	13.1	1.79
30	12.3	2.38
32.5	11.2	1.63
35	10.2	0.24
37.5	9.6	0.15
40	9.6	0.12

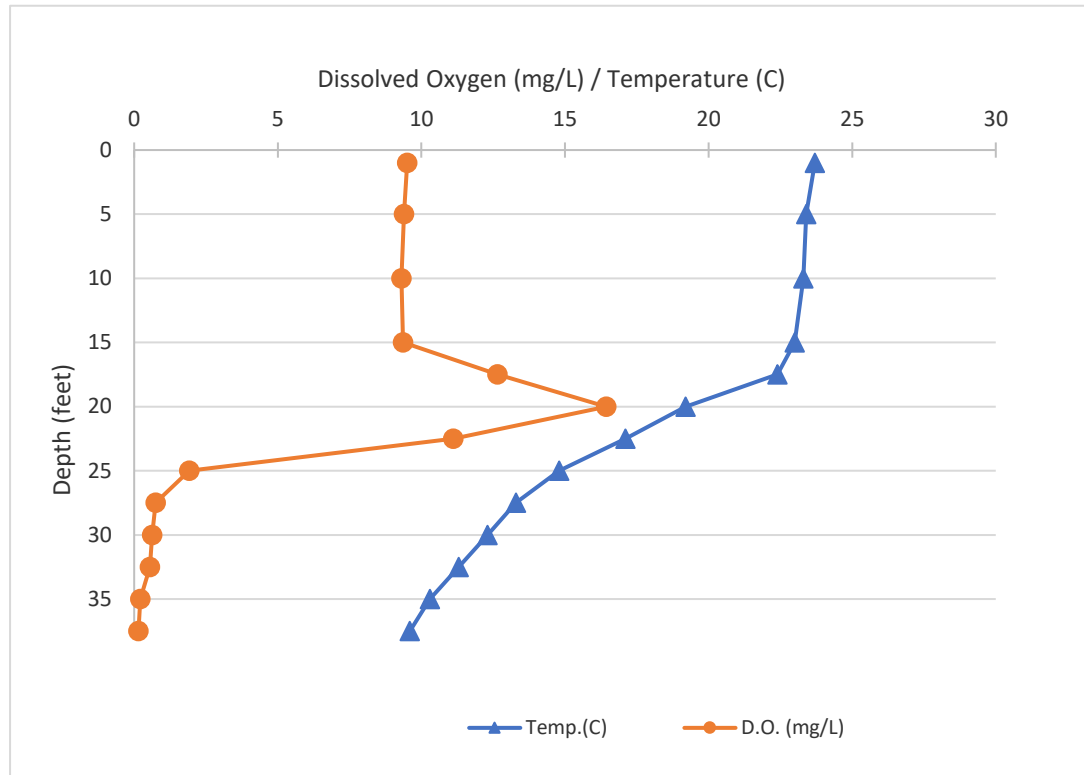
9/9/2022

### Dissolved Oxygen and Temperature Profile

Depth (ft)	Temp.(C)	D.O. (mg/L)
1	23.7	9.51
5	23.4	9.4
10	23.3	9.31
15	23	9.36
17.5	22.4	12.65
20	19.2	16.44
22.5	17.1	11.11
25	14.8	1.92
27.5	13.3	0.75
30	12.3	0.63
32.5	11.3	0.55
35	10.3	0.21
37.5	9.6	0.15

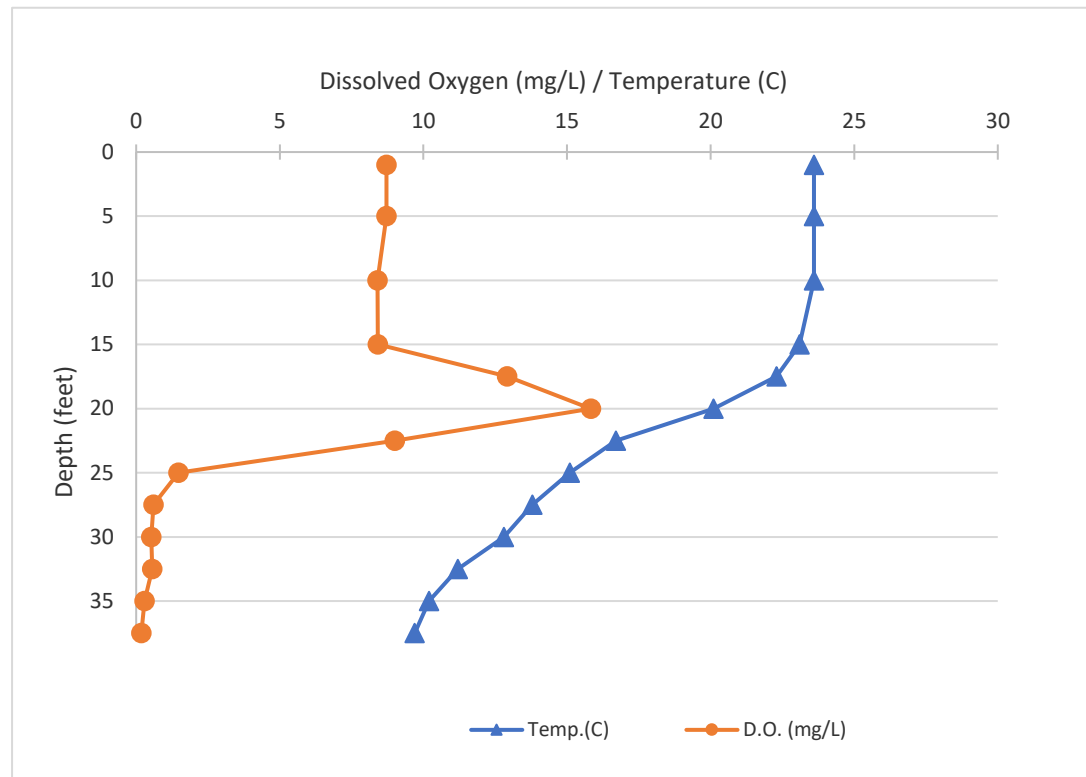
9/11/2022

### Dissolved Oxygen and Temperature Profile

Depth (ft)	Temp.(C)	D.O. (mg/L)
1	23.6	8.71
5	23.6	8.71
10	23.6	8.4
15	23.1	8.41
17.5	22.3	12.92
20	20.1	15.83
22.5	16.7	9.01
25	15.1	1.47
27.5	13.8	0.6
30	12.8	0.53
32.5	11.2	0.56
35	10.2	0.29
37.5	9.7	0.18
